ACE Project Report

Tonto National Forest, Arizona Trail Association and Arizona State Parks

Title of Project: 4 Peaks Trail Maintenance **Award Contract Number:** ASP NM11021

Location: 4 Peaks Wilderness, Tonto National Forest

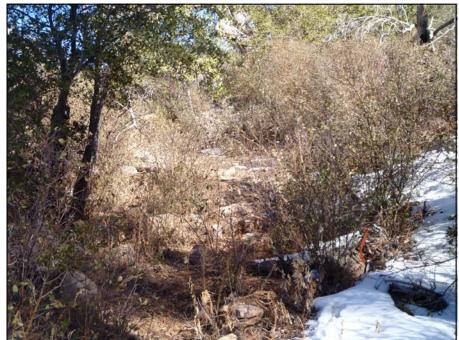
The photo at left shows a great example of the typical conditions found on the trail. Brushing had not been performed recently, making the trail corridor extremely narrow and difficult to travel through.

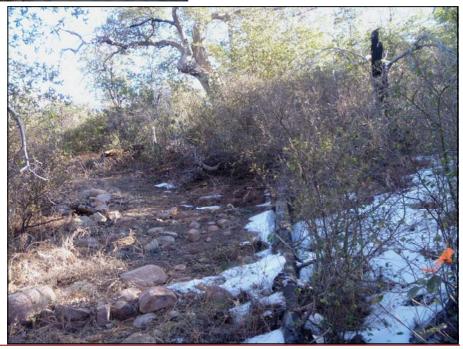
The photo at right shows the same corridor after it had been brushed. The crew worked to re-establish the six foot wide corridor on the entire length of the project.

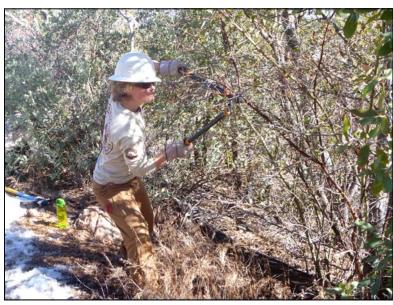
At right, a crew member works to widen the trail corridor. This photo is a good example the type and thickness of the brush encountered on this project.

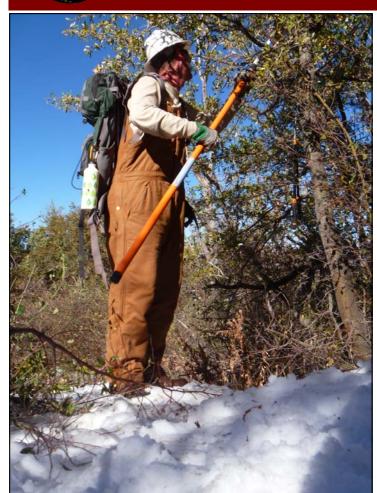
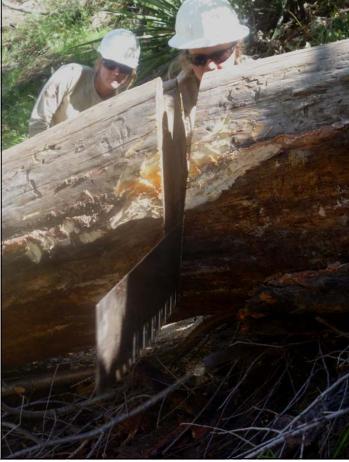
While the smaller woody brush was thick., there was also tree trimming required to get the corridor up to Forest Service standards. Pole saws and larger hand saws were used to ensure the corridor was cleared to the proper specifications.

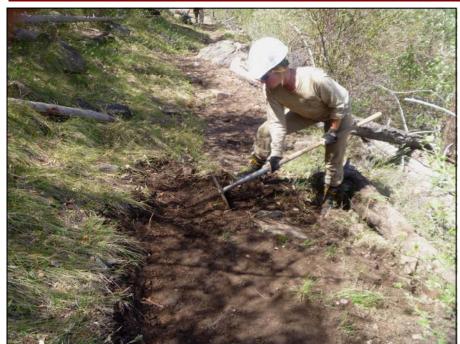
Much of the tread on the trail needed to be widened and out sloped. The photo at left shows a crew member working to re-establish the trail in a sustainable fashion.

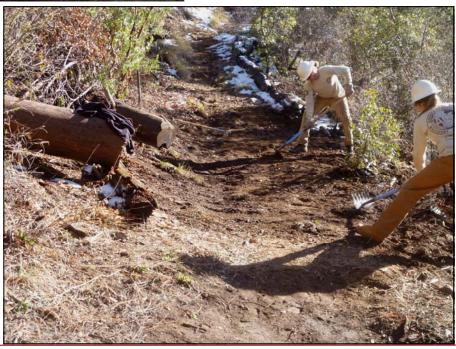
The photo at right shows two crew members working on the tread. The lower right portion of the photograph shows a small berm on the down hill side of the trail. The crew spent a lot of time removing berms such as these to allow sheet flow on the trail. Sheet flow preserves the natural hydrology of the land by allowing water to flow down on to the trail, and sheet off without the trail funneling the water down the tread way.

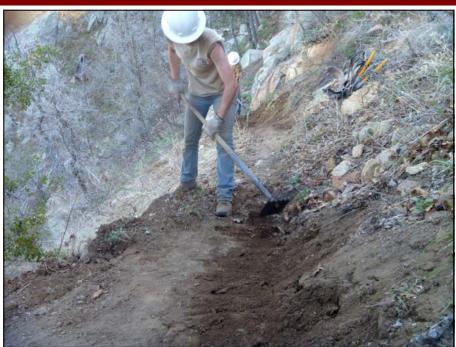
The photo at right shows a crew member widening the tread. Notice the steep cross slope the trail exists on. These steep slopes, over time, slough rocks and soil down on to the trail. In many places, sloughing had occurred narrowing the trail below Forest Service specifications. Widening the trail creates a more sustainable and safe trail for users.

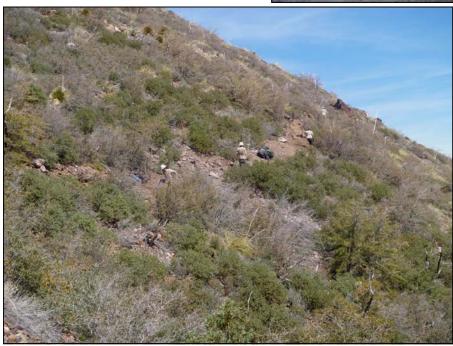
The photo at left shows the crew performing tread work.

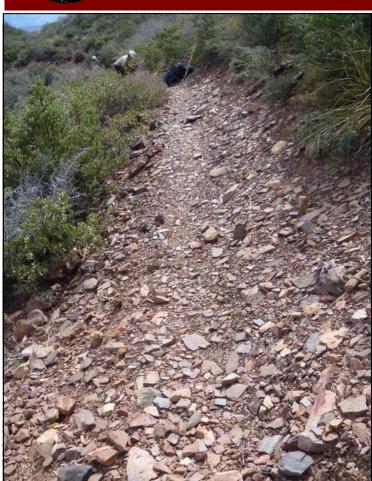
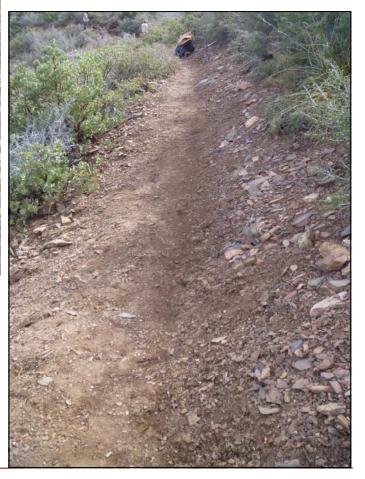
This page shows before and after photos of a section of trail that has been widened and out sloped. Sloughing has occurred on this trail

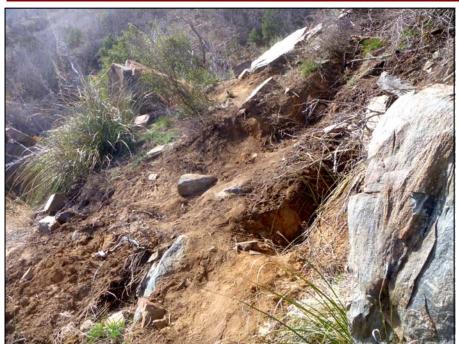
The photo at left shows a section of trail that had been damaged by a rockslide. The photo shows large holes and trail tread that has been carried away. This slide occurred during the course of the project and the crew wanted to ensure that the trail would be passable for all users.

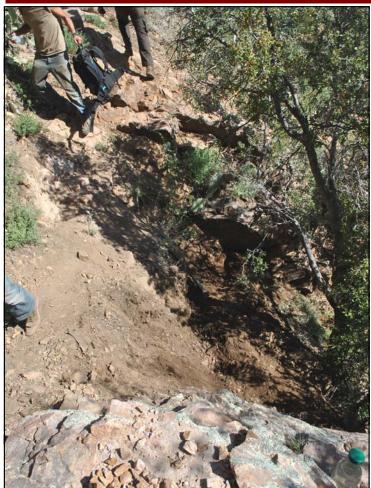
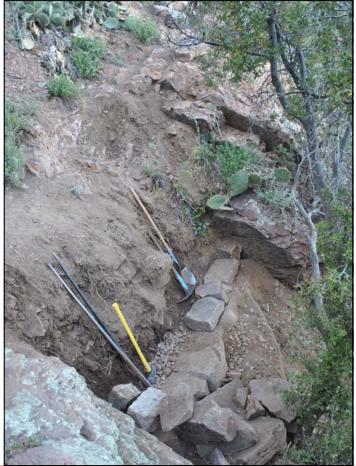
The final eight day work hitch found the crew at a section of trail that had been compromised. At both work sites, there was evidence of retaining walls that had been built, and then lost due to the forces of nature. In both of these sites, the trail was dangerously narrow and unstable, and miss steps by hikers or horses would have serious consequences.

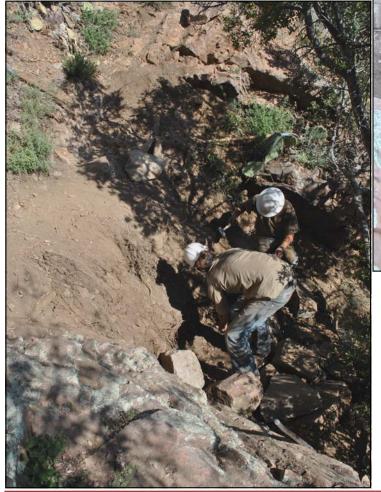
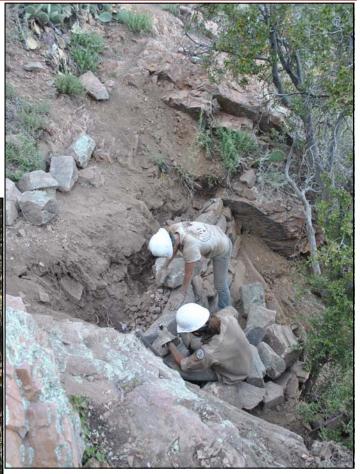
More photos of the crew working on the wall. Progress seemed slow at times, but the crew had an ideal source of angular stone just down the trail. The amount of rock gathered ensured they would have the material needed to complete the job.

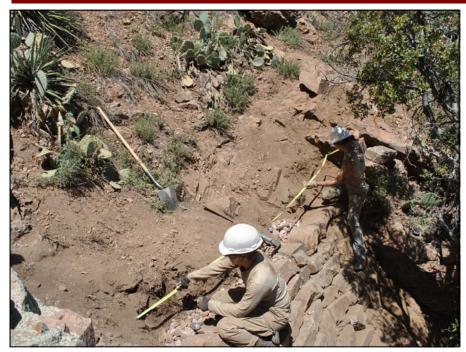
The photo at left shows crew members measuring the wall in preparation for the cap stones. The cap stones are large rocks that dictate the height of the wall and the level of the trail. They need to be large to withstand time and the pressure of horse traffic.

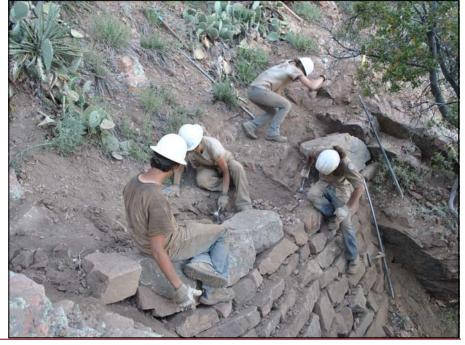
The photo at right shows the crew working hard to finish before the end of the hitch.

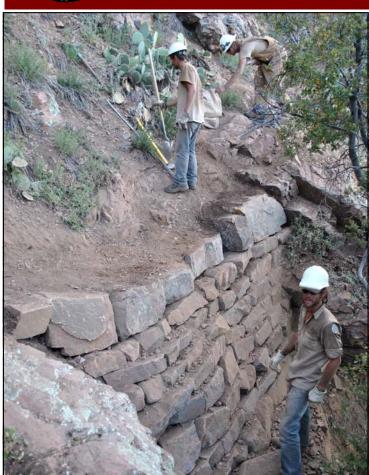
This page shows the crew putting on the finishing touches to the wall and preparing to re-establish the tread. The photo below shows proud crew members enjoying their work.

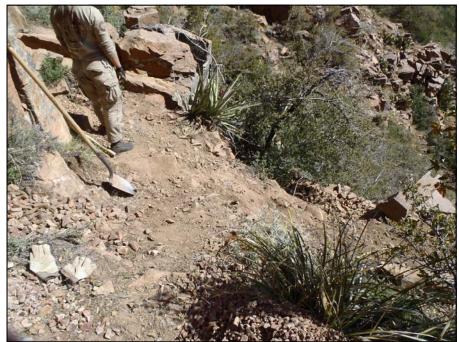
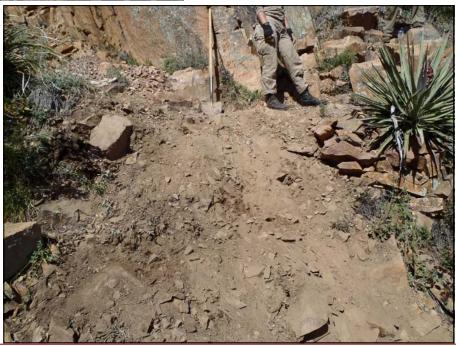
The photos shown here are from work site 2. Again, the wall had collapsed leaving a thin and unstable trail. The photo below shows the size of the damage. Notice the right side of the photo, underneath the Yucca, what remains of the original retaining wall.
